Subject: SOFT TOP SPLIT	Bulletin No: 09-003/03
	Last Issued: 2/7/2003

All 1999-2001 Miata and 2002 Miata with VIN before JM1NB353**0 231580.

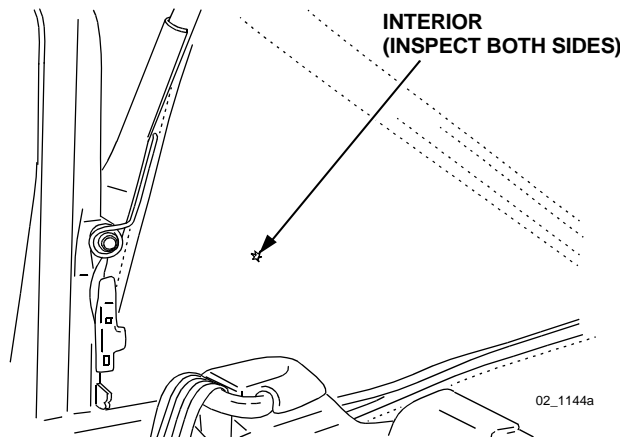
1. Verify condition by inspecting the soft top fabric for splitting or holes in B-pillar area of soft top.
 - If soft top wear marks are visible only at the vehicle interior side and have not worn through to exterior, then soft top replacement is not required. Skip to Step 5 and replace only the RH and LH Set Plates.

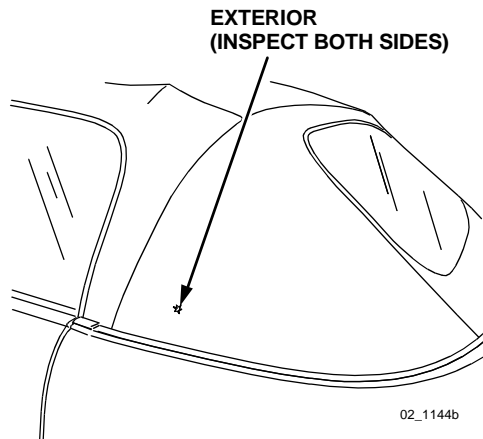
- If splitting of holes are visible on the exterior of the soft top, then proceed to the next steps for replacing both the soft top fabric and the set plates.

2. Remove the convertible top following removal procedure in the applicable Workshop Manual (Convertible Top Removal / Installation section 09-16).
3. Disassemble and replace the soft top fabric from the mechanism assembly following the procedure in the applicable Workshop Manual (Top Fabric Removal / Installation section 09-16).
4. Reinstall the convertible top following installation procedure in the applicable Workshop Manual (Convertible Top Removal / Installation section 09-16).
