Section <b>09</b>	Applicable Model/s <b>1999 Miata</b>	Subject <b>SOFT TOP COVER COMES OFF OR BREAKS</b>	Bulletin No. <b>007/99R</b>
			Issued <b>05/21/99</b>
			Revised <b>06/04/99</b>

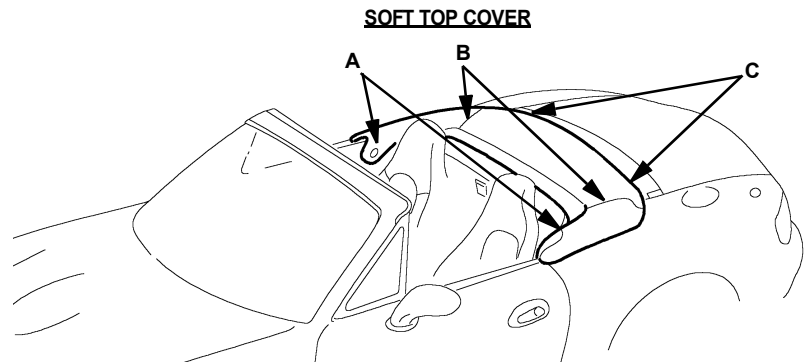
- A. Soft top may tear when trying to remove it due to fasteners connecting too tightly.
- B. Soft top cover cloth gradually comes apart at the seams due to wind pressure.
- C. Soft top cover fastener(s) may fly off from wind pressure while driving.

- Verify customer concern.
- Replace soft top cover with modified part.
- Verify repair.
